THE FORENSIC ENGINEERING REPORT

A \$3 ITEM.....A \$90,000 LOSS *HAVE NO FEAR... DEZINCIFICATION IS HERE*

Sea Strainer Pipe Fitting Failure

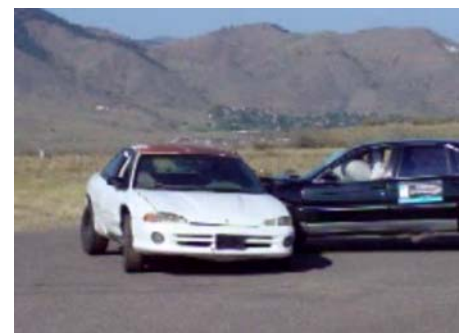
Image of the 90-degree impact of the test vehicle with the target vehicle. Note the inflated driver's airbag.

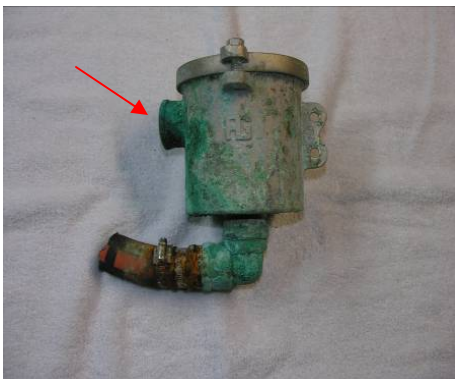
Photo P-1

Our assignment at Trnka Engineers Co. was to determine the cause of the fitting failure. The cause of the failure could possibly provide the basis for subrogation of the claim. The evidence, the sea strainer and pipe fitting, was provided to us by the adjuster as seen in Photo P-1. The broken fitting location is indicated by the red arrow.

A quick 10x magnification inspection of the broken pipe fitting gave us cause to suspect that a brass pipe fitting was used in the sea water cooling system where bronze, a more appropriate pipe fitting material, should have been used.

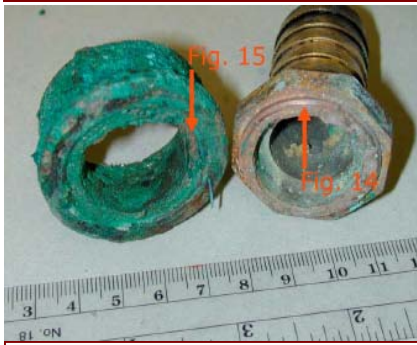
Photo P-2

There are many copper based alloys, however, only a few are suitable for extended exposure to salt water. Copper alloys with relatively high zinc content when exposed to salt water will succumb to a phenomenon termed “selective leaching” or otherwise known as “dezincification”. The phenomenon in this case is that the zinc, in constant contact with salt water, goes into solution with the sea

water and over time leaches out of the pipe fitting. As one would easily conclude the zinc eventually dissolves out of the pipe fitting leaving only the copper base material along with some trace elements. This remaining material is very brittle and fractures easily as occurred in this situation.

A closer view is seen in the Photos P-2 and P-3. Note the “spongy” appearance of the fractured pipe fitting surface in Photo P-3. The spongy appearance occurs with the migration of the zinc out of the copper base material of the pipe fitting.

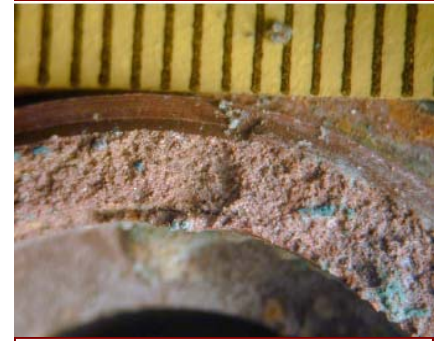
Photo P-3

The laboratory findings did indeed confirm the fitting to be brass and dezincification did occur as a result of exposure to sea water. This finding was then reported to the adjuster who now had opportunity to subrogate back to the yacht builder.

Note the “Spongy” Appearance

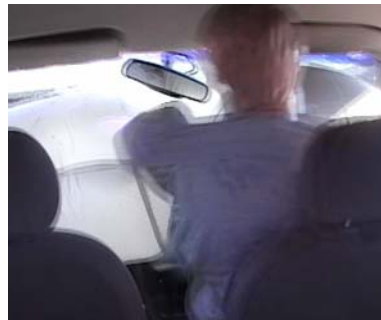
A sequence of in-car images taken during the crash test. Note that both driver and passenger airbags were deployed, protecting the otherwise vulnerable crash dummy from an uncertain fate. No dummies were harmed in the creation of these images.
